TECHNICAL REPORT

Oil pan gasket 14028900
assembly for Nissan Patrol
A.428

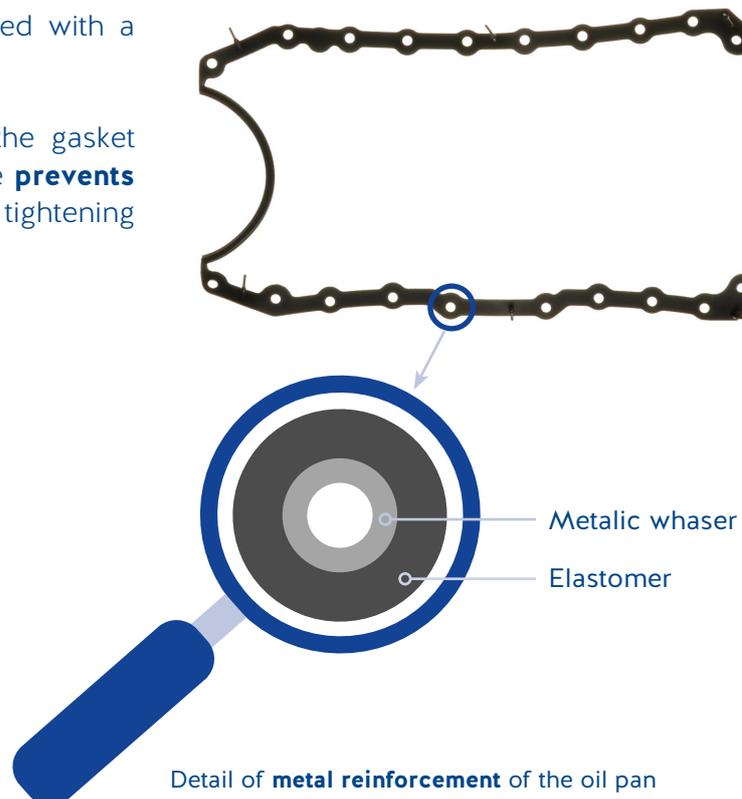
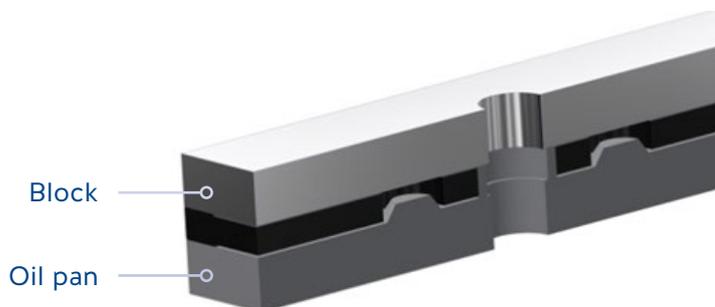
The oil pan gasket 14028900 is provided with a **metal reinforcement** in all screw holes.

This limits the sealing pressure from the gasket itself and not from the oil pan, therefore **prevents the gasket from cracking** during the tightening procedure.

Metalic washer
(Pressure limiter)

The gasket has multiple **inserts** that are used to place the gasket in its correct position and prevent it from being stepped on. These inserts are indicated with the letter A in the image.
